**Subject: Site Assessment Report
 Stetzer Road Landfill
 Bucyrus, Crawford County, Ohio
 Technical Direction Document No. S05-0309-007
 Tetra Tech Contract No. 68-W-00-129**

**SITE ASSESSMENT REPORT
STETZER ROAD LANDFILL SITE
BUCYRUS, CRAWFORD COUNTY, OHIO**

TDD No.:	S05-0309-007
Date Prepared:	December 31, 2004
Contract No.:	68-W-00-129
Prepared by:	Tetra Tech EM Inc.
Tetra Tech START Project Manager:	Stephen A. Wolfe
Telephone No.:	(440) 234-0886
U.S. EPA On-Scene Coordinator:	Brad Stimple
Telephone No.:	(440) 250-1717

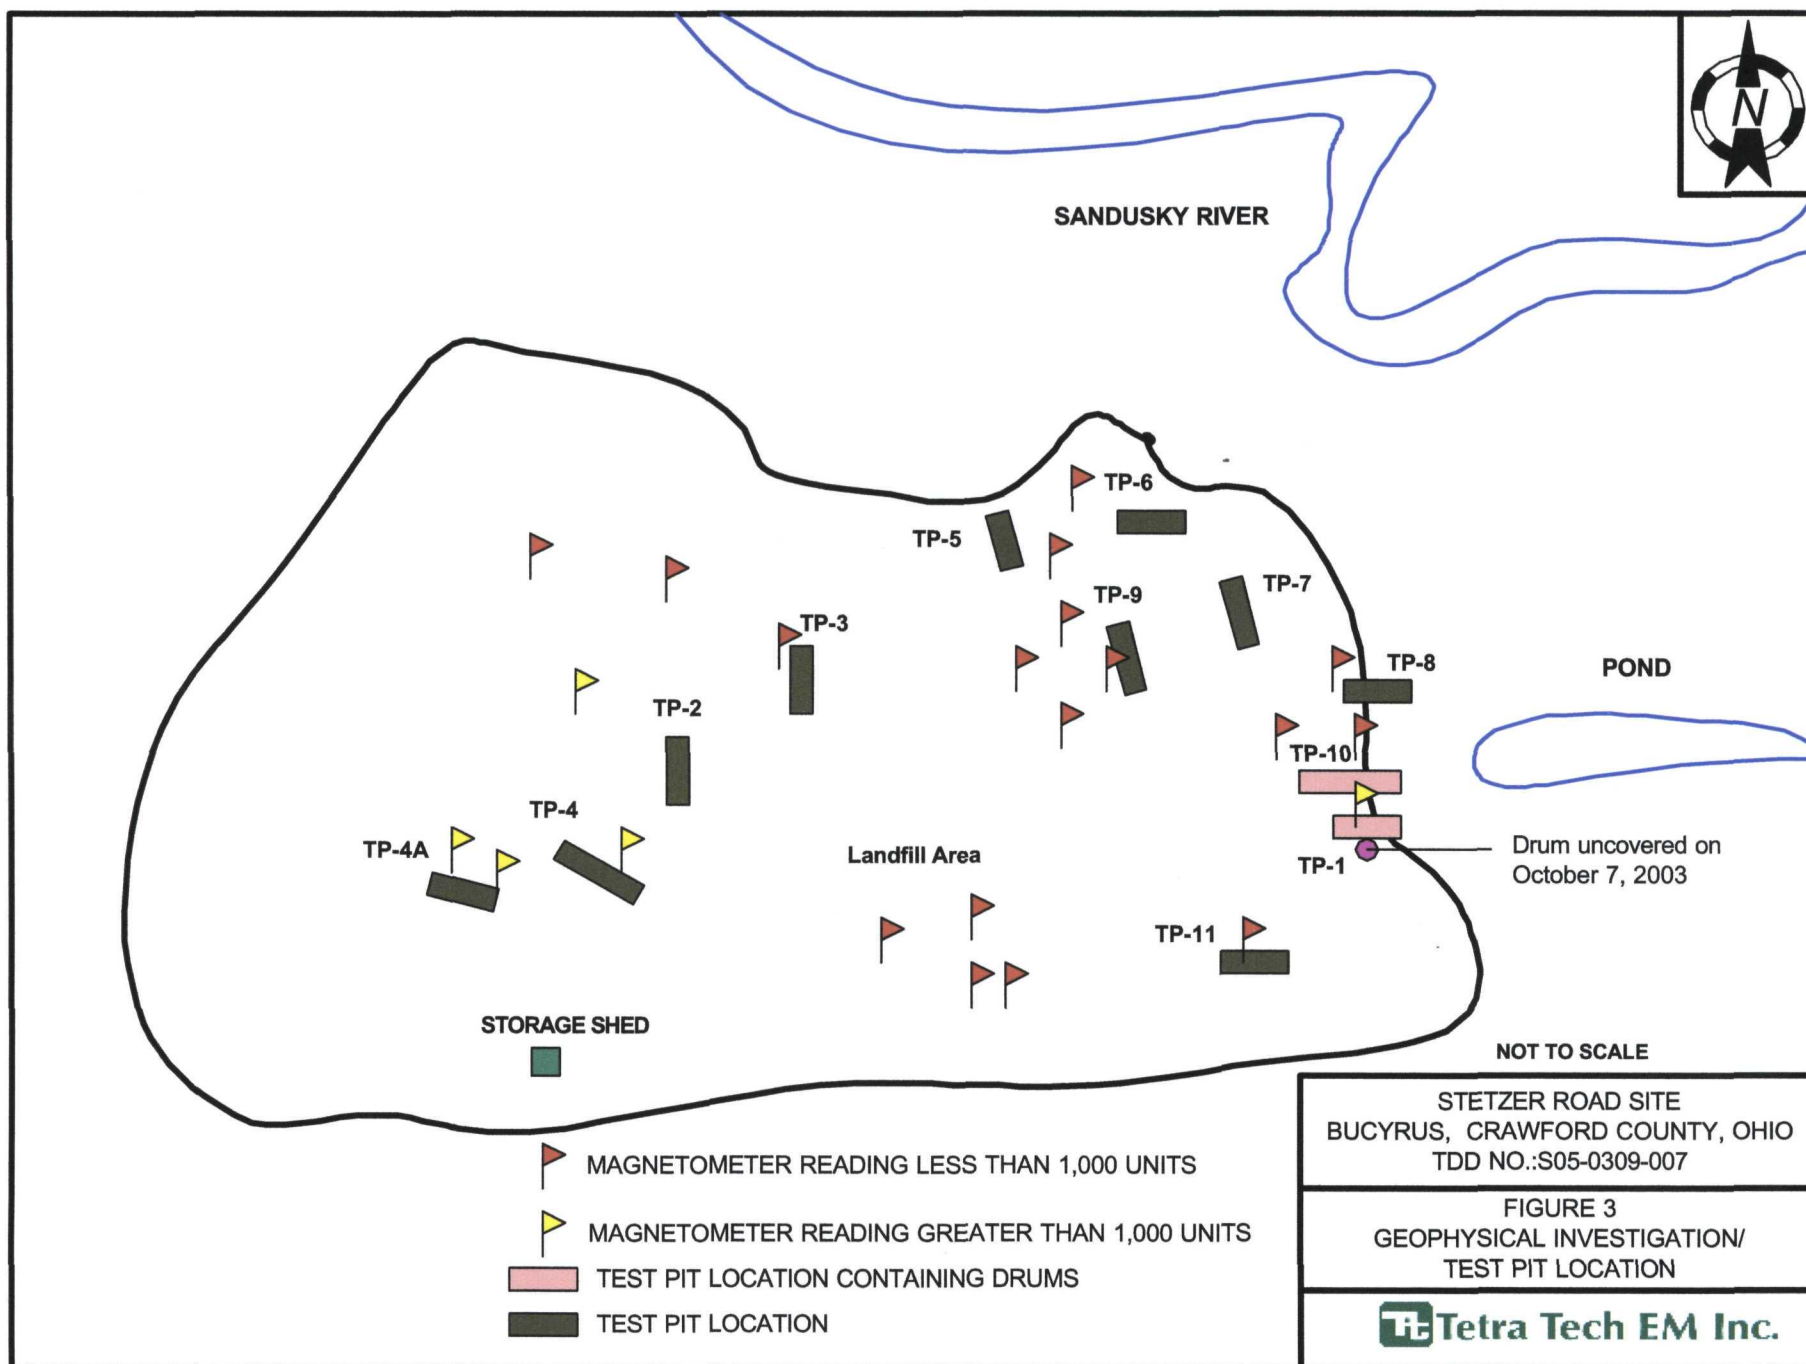
On October 7, 2003, U.S. EPA, Ohio EPA, START and a representative from the Potentially Responsible Party (PRP) was on site to conduct a geophysical survey. A magnetometer was used to survey the site and areas were marked with a red flag (readings less than 1,000 units) or a white flag (readings greater than 1,000 units). See Figure 3 for results of the geophysical survey.

A total of twelve test pits were excavated on the site (Figure 3). All test pits were dug until native soil was encountered or until the 10-foot depth limit of the excavator was reached. The test pits contained mostly rubber hoses as fill material with some plastic wrapping material. A large metal cable was uncovered at 3 feet below ground surface (bgs) in test pits 4 and 4a, and digging stopped at approximately 5 feet bgs when soil was encountered. The ends of the cable could not be located and seemed to run in a northeast/southwest direction. A total of 13 crushed and deteriorated drums were found in test pits 1 and 10, which were located on the eastern side of the property. The drums were removed from the test pits and placed on visqueen for further evaluation.

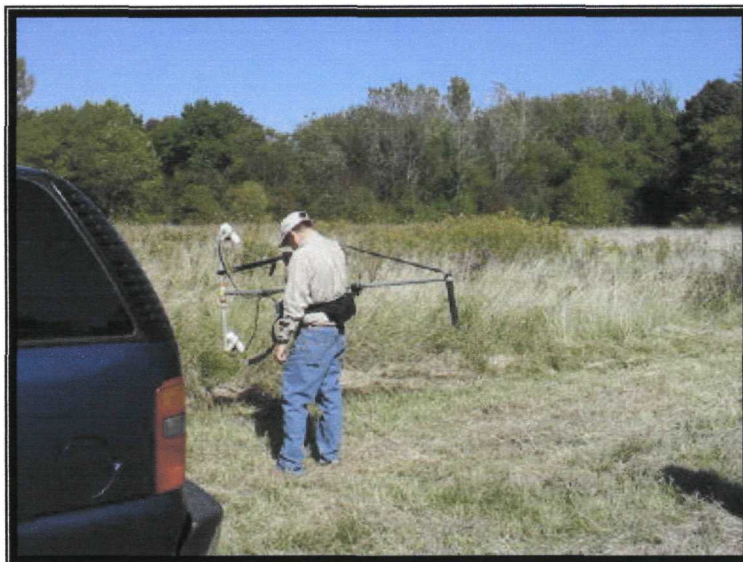
Photograph No. 1 **Date:** October 7, 2003
TDD No.: S05-0309-007 **Orientation:** East
Location: Stetzer Road Landfill site
Subject: U.S. EPA personnel performing a geophysical survey with a magnetometer

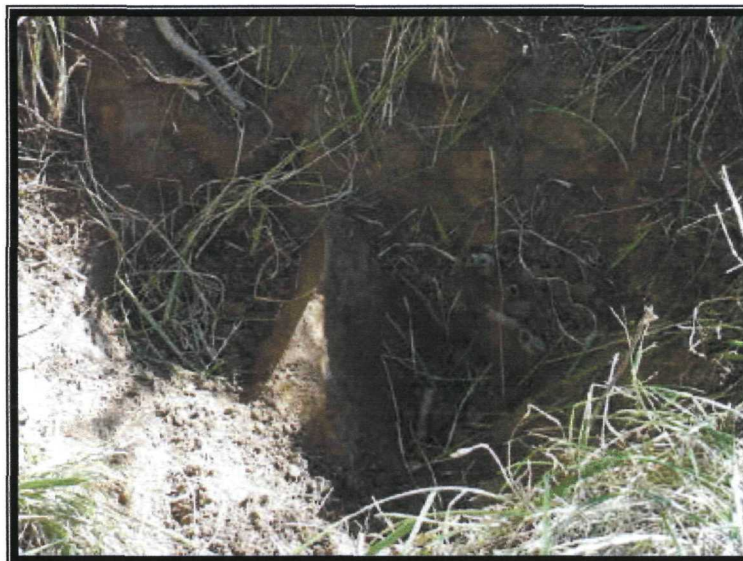
Photograph No. 2 **Date:** October 7, 2003
TDD No.: S05-0309-007 **Orientation:** Down
Location: Stetzer Road Landfill site
Subject: Drum that was uncovered on the east side of the property

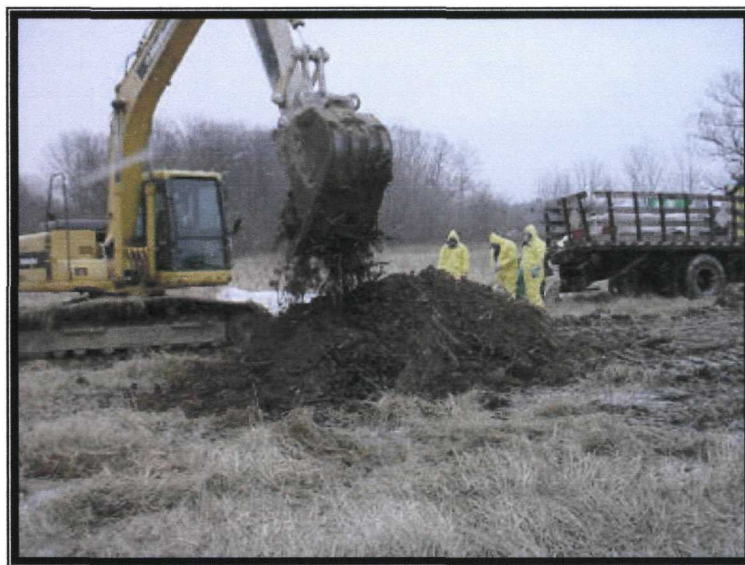
Photograph No. 3 **Date:** December 17, 2003
TDD No.: S05-0309-007 **Orientation:** North
Location: Stetzer Road Landfill site
Subject: Excavating a test pit

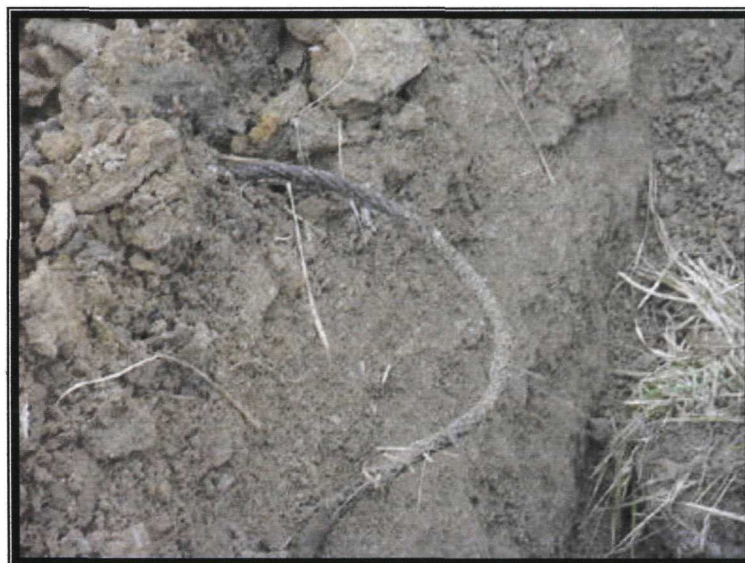
Photograph No. 4 **Date:** December 17, 2003
TDD No.: S05-0309-007 **Orientation:** Down
Location: Stetzer Road landfill site
Subject: Metal cable that was uncovered in test pits 4 and 4a

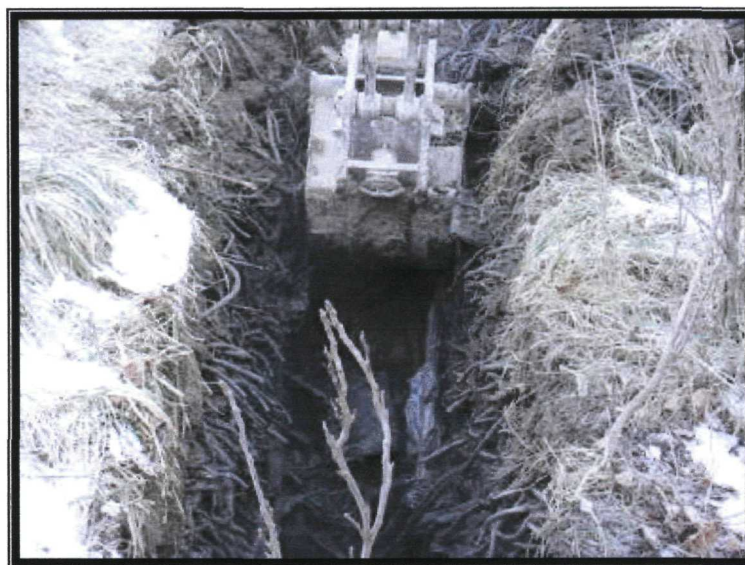
Photograph No. 5 **Date:** December 17, 2003
TDD No.: S05-0309-007 **Orientation:** Down
Location: Stetzer Road Landfill site
Subject: Excavating a test pit

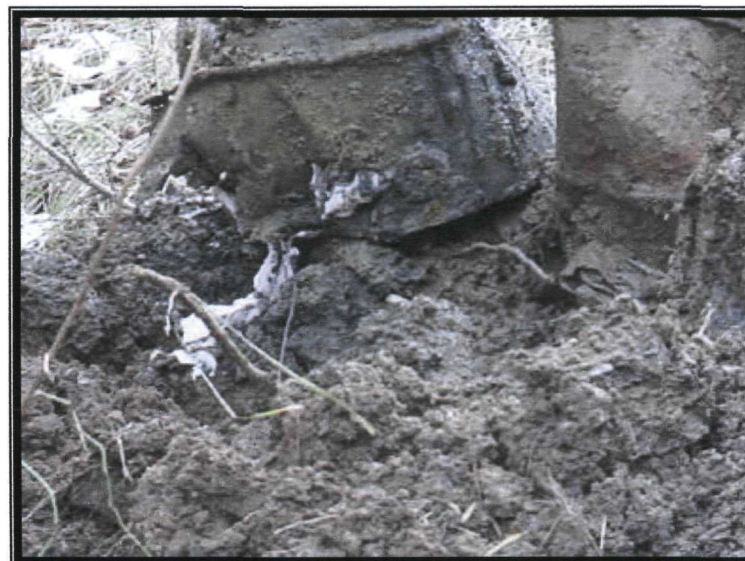
The analytical results indicated that the composite sample of the waste material was hazardous for lead and cadmium. The Total Characteristic Leachate Property (TCLP) result for lead was 7.0 milligrams per liter (mg/l) and the TCLP result for cadmium was 3.2 mg/l. TCLP regulations for wastes in a landfill are 5.0 mg/l for lead and 1.0 mg/l for cadmium.

Photograph No. 6 **Date:** December 17, 2003
TDD No.: S05-0309-007 **Orientation:** Down
Location: Stetzer Road Landfill site
Subject: Drum leaking white material

The PRP (Thomas Betts company) will properly dispose of the drums that were uncovered and overpacked during the site assessment.

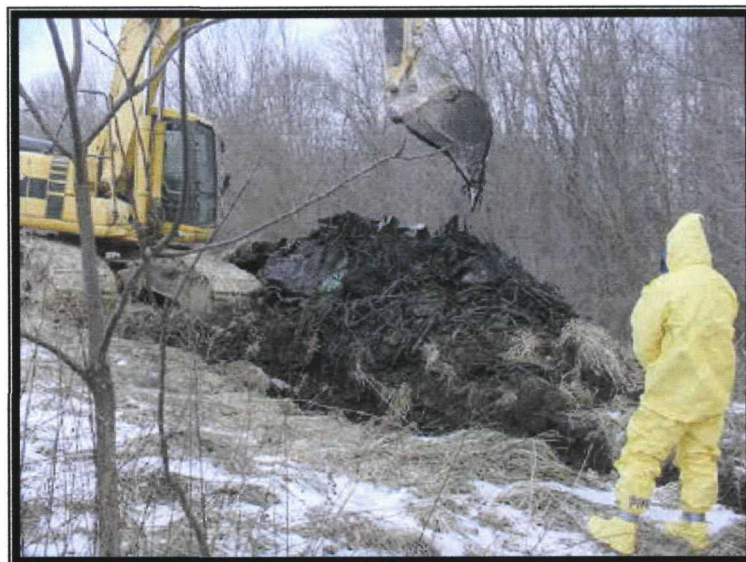
Photograph No. 7 **Date:** December 18, 2003
TDD No.: S05-0309-007 **Orientation:** East
Location: Stetzer Road Landfill site
Subject: Excavating a test pit

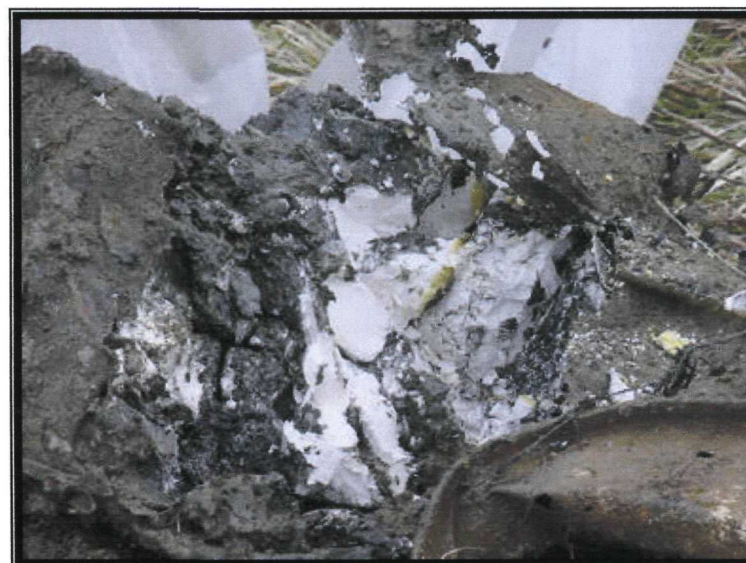
Photograph No. 8 **Date:** December 18, 2003
TDD No.: S05-0309-007 **Orientation:** Down
Location: Stetzer Road Landfill site
Subject: Excavated half-drum filled with a white material

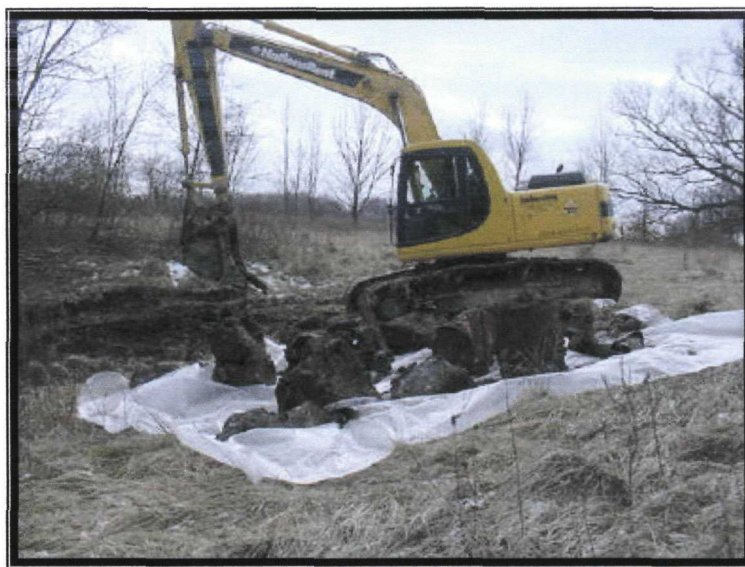
Photograph No. 9 **Date:** December 18, 2003
TDD No.: S05-0309-007 **Orientation:** South
Location: Stetzer Road Landfill site
Subject: Excavated drums staged on plastic sheeting.
